# The Woodland

Findings of the Historic Preservation Plan

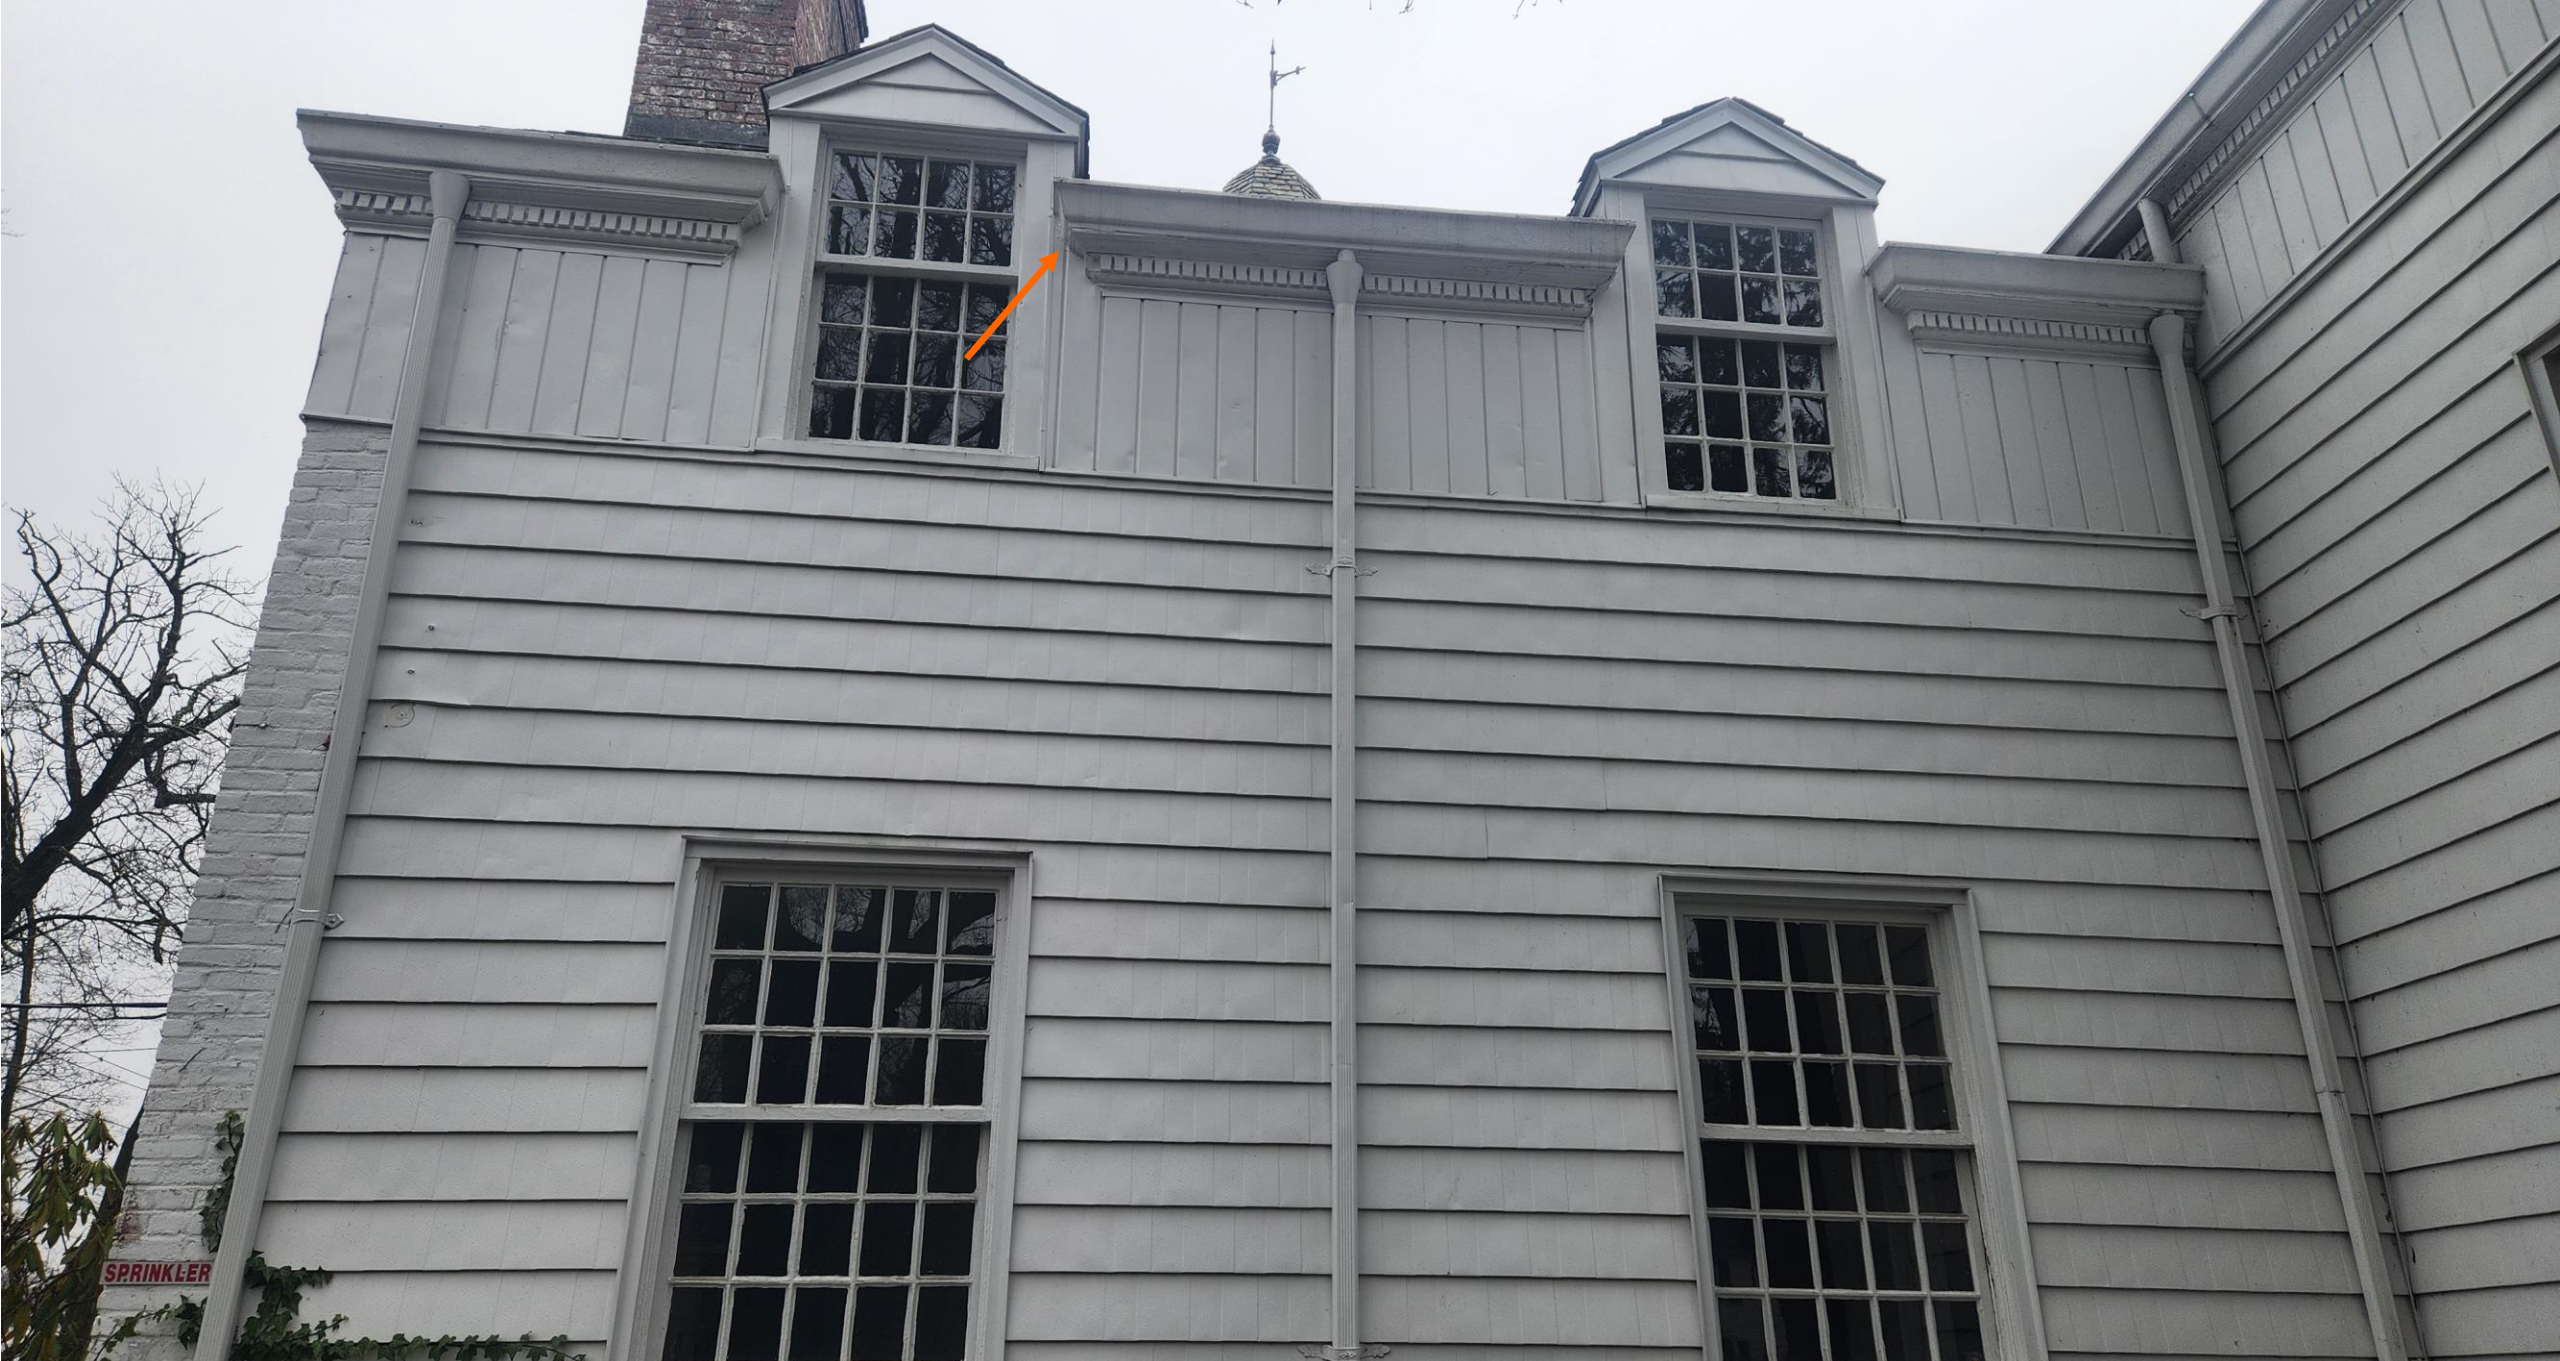
View of the typical detailing of the built-in gutter with some wood rot starting to show.

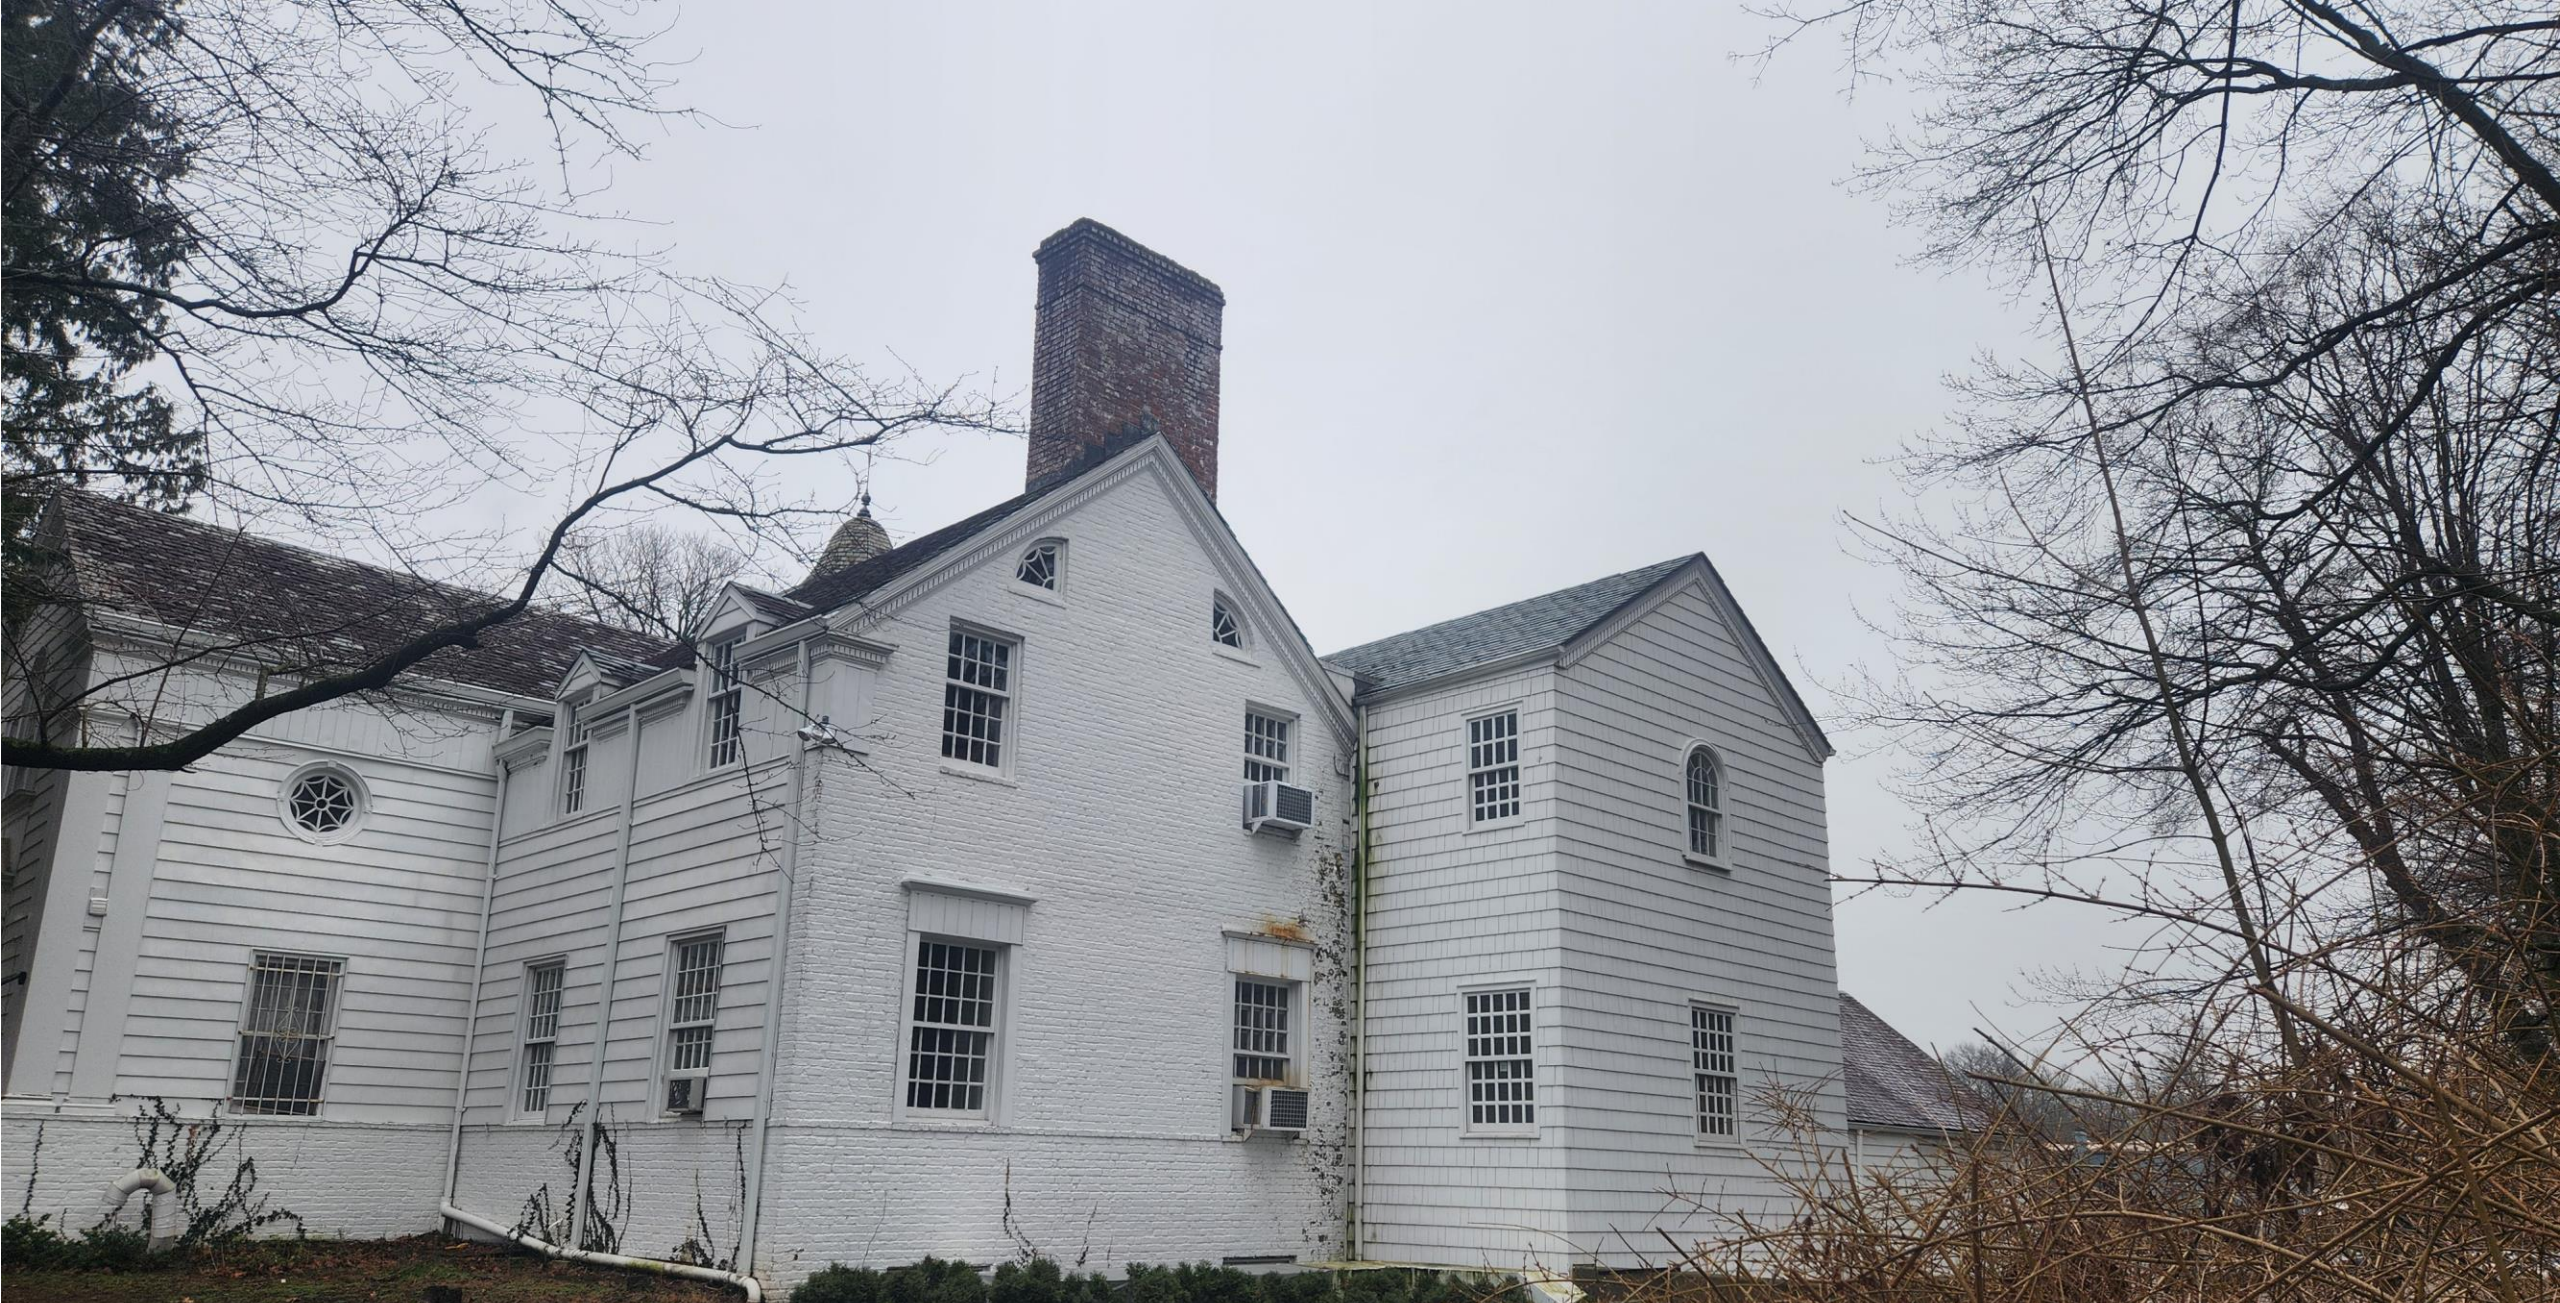
View of the west chimney at the main section roof; the east chimney exhibit similar conditions and both exhibit mortar loss, soiling, and what appears to be paint residue.

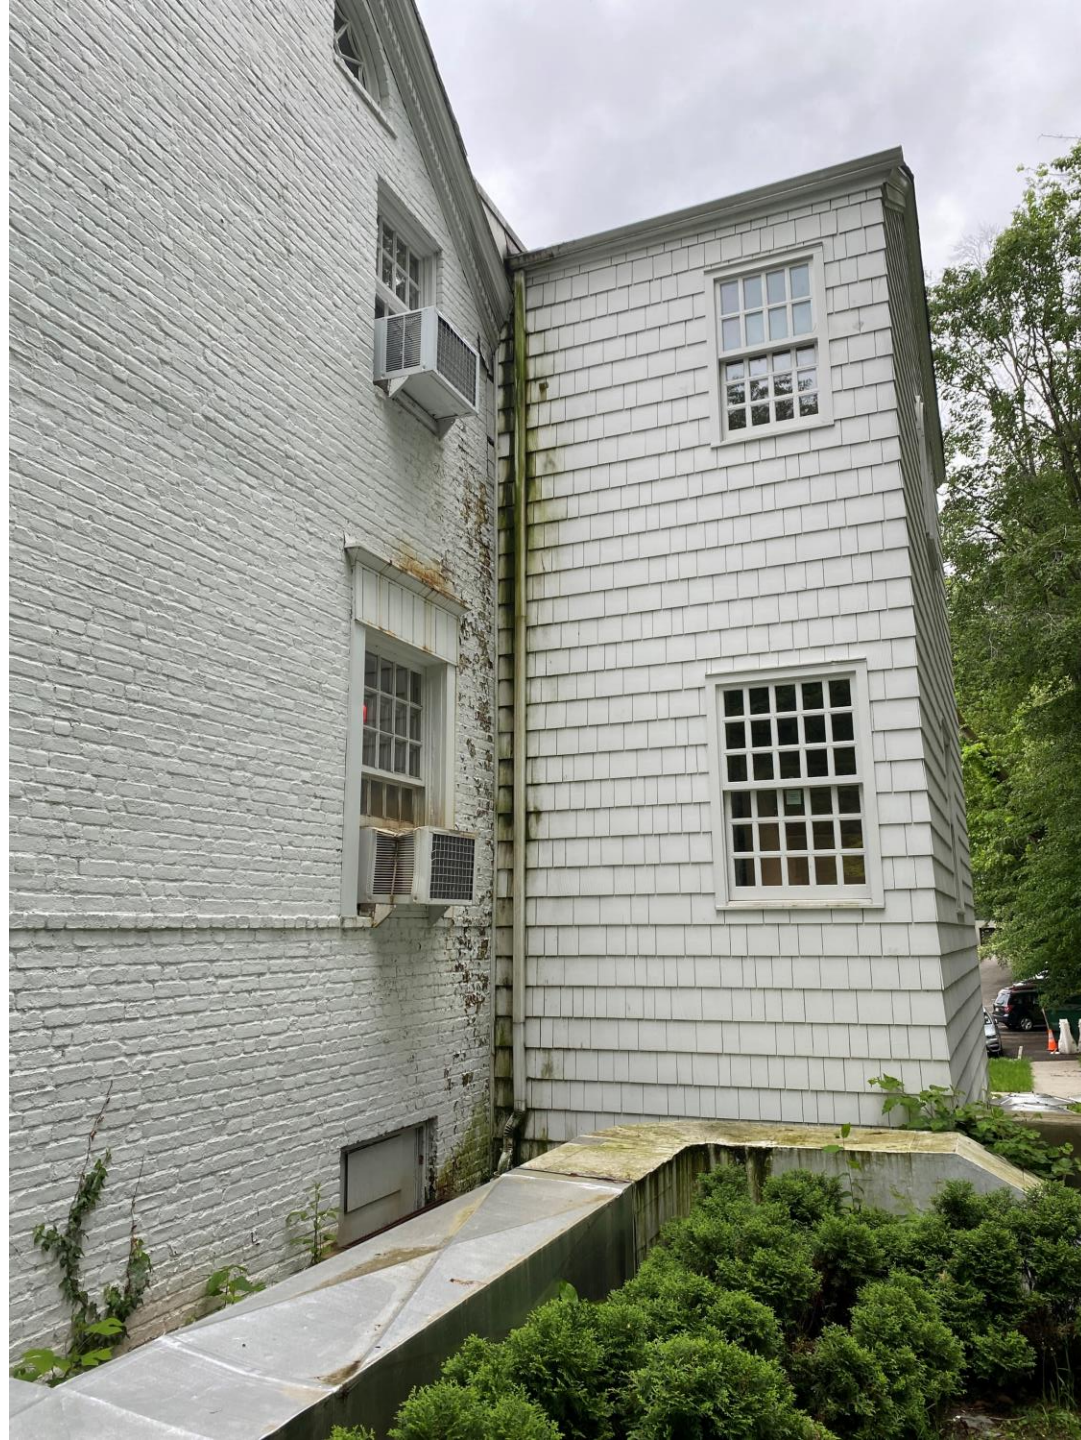
Views of the transition between the main building and stair/ elevator addition.

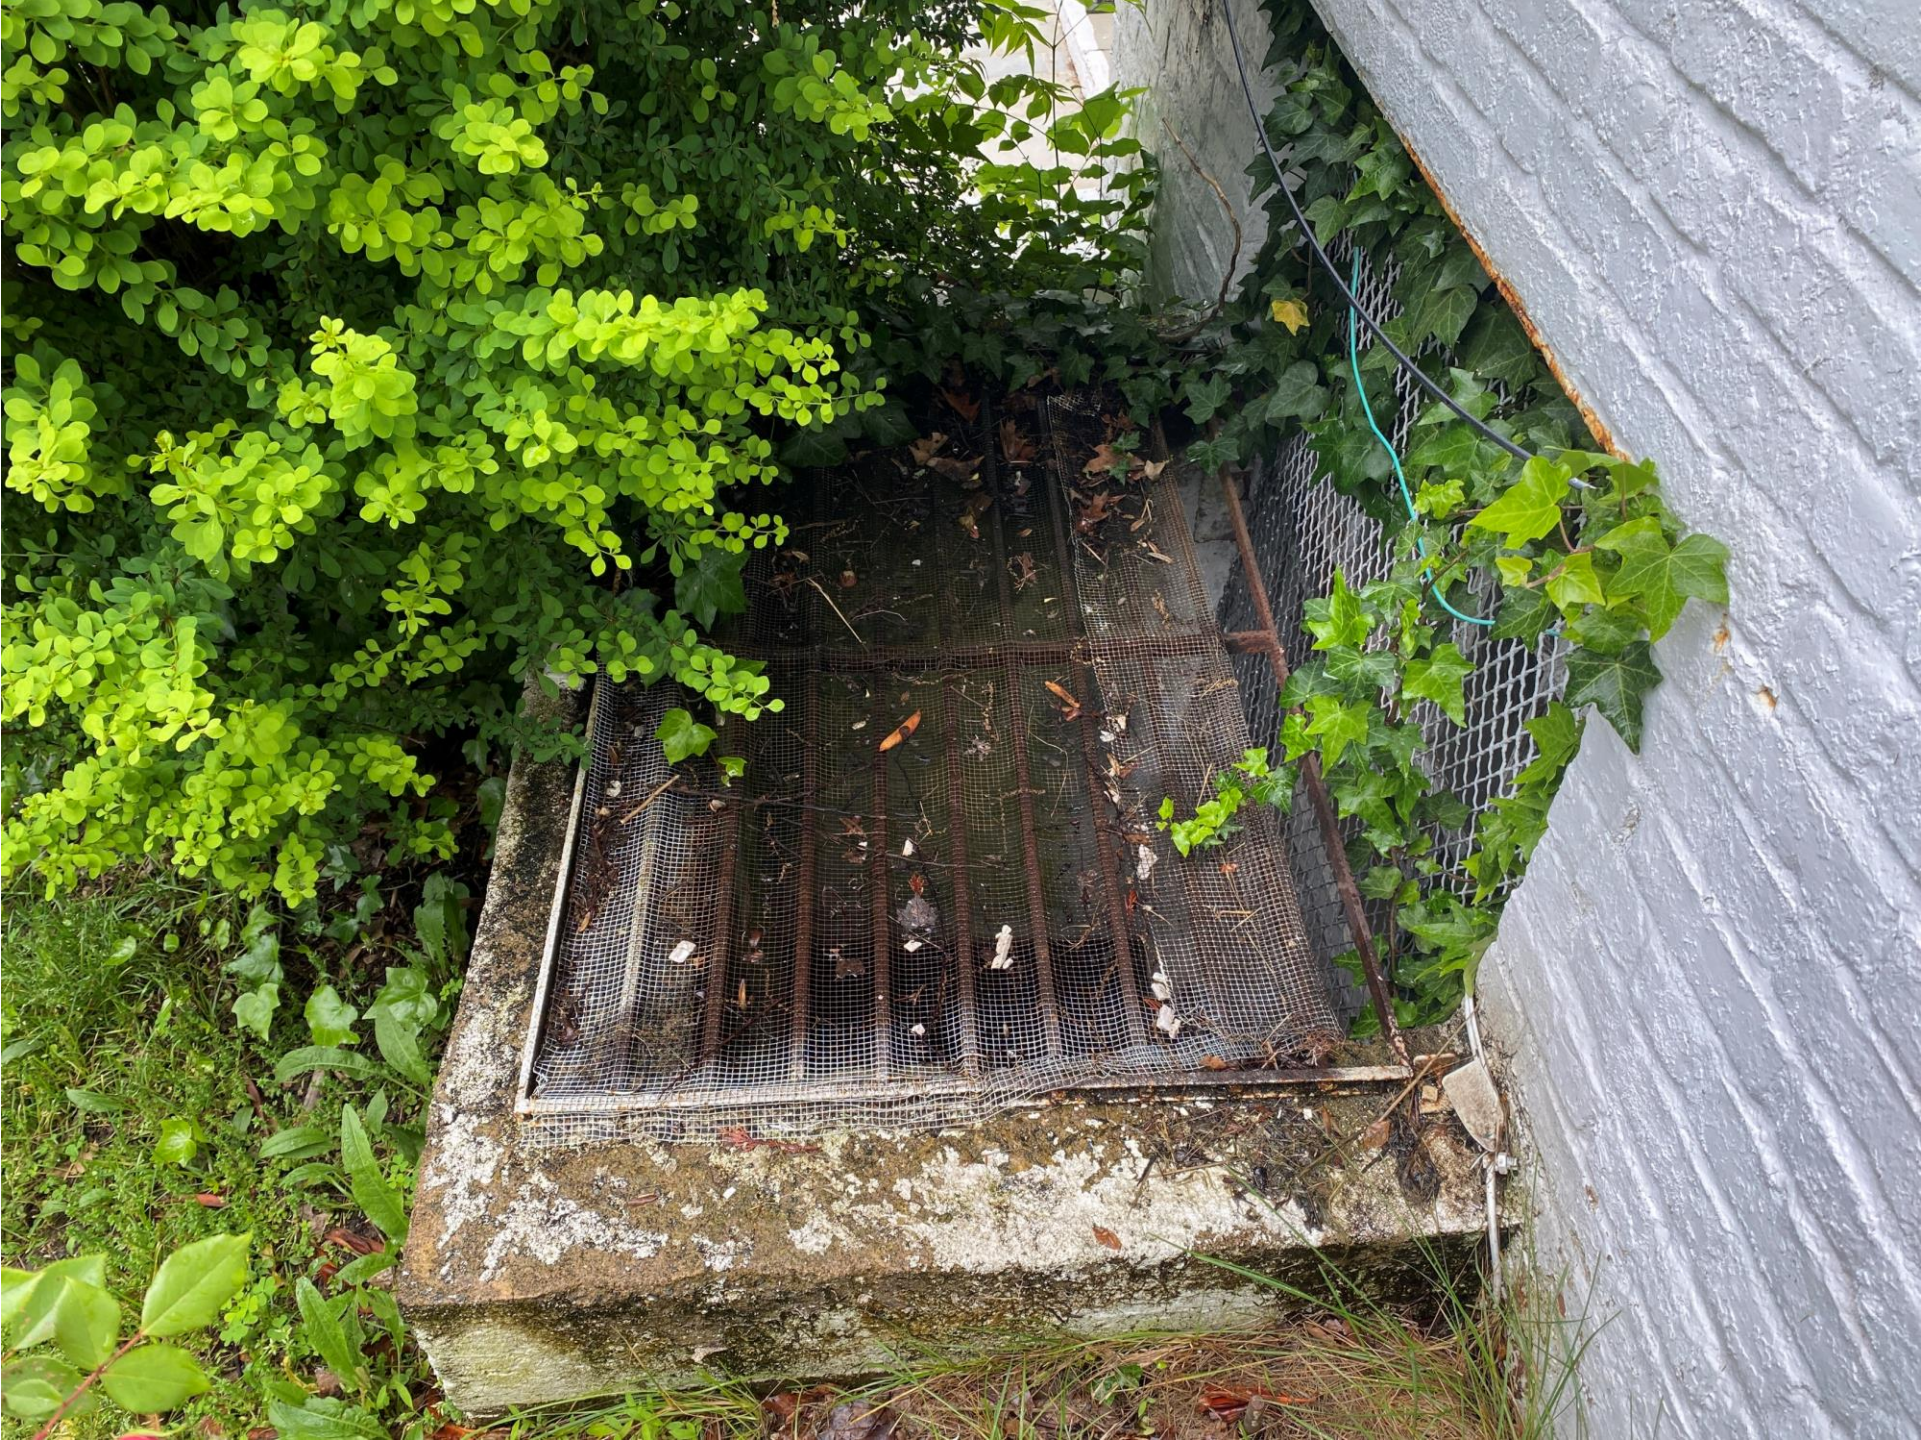
View of the  
typical  
window wells  
and  
areaways  
which have  
overgrowth,  
poorly  
installed  
covers, etc.

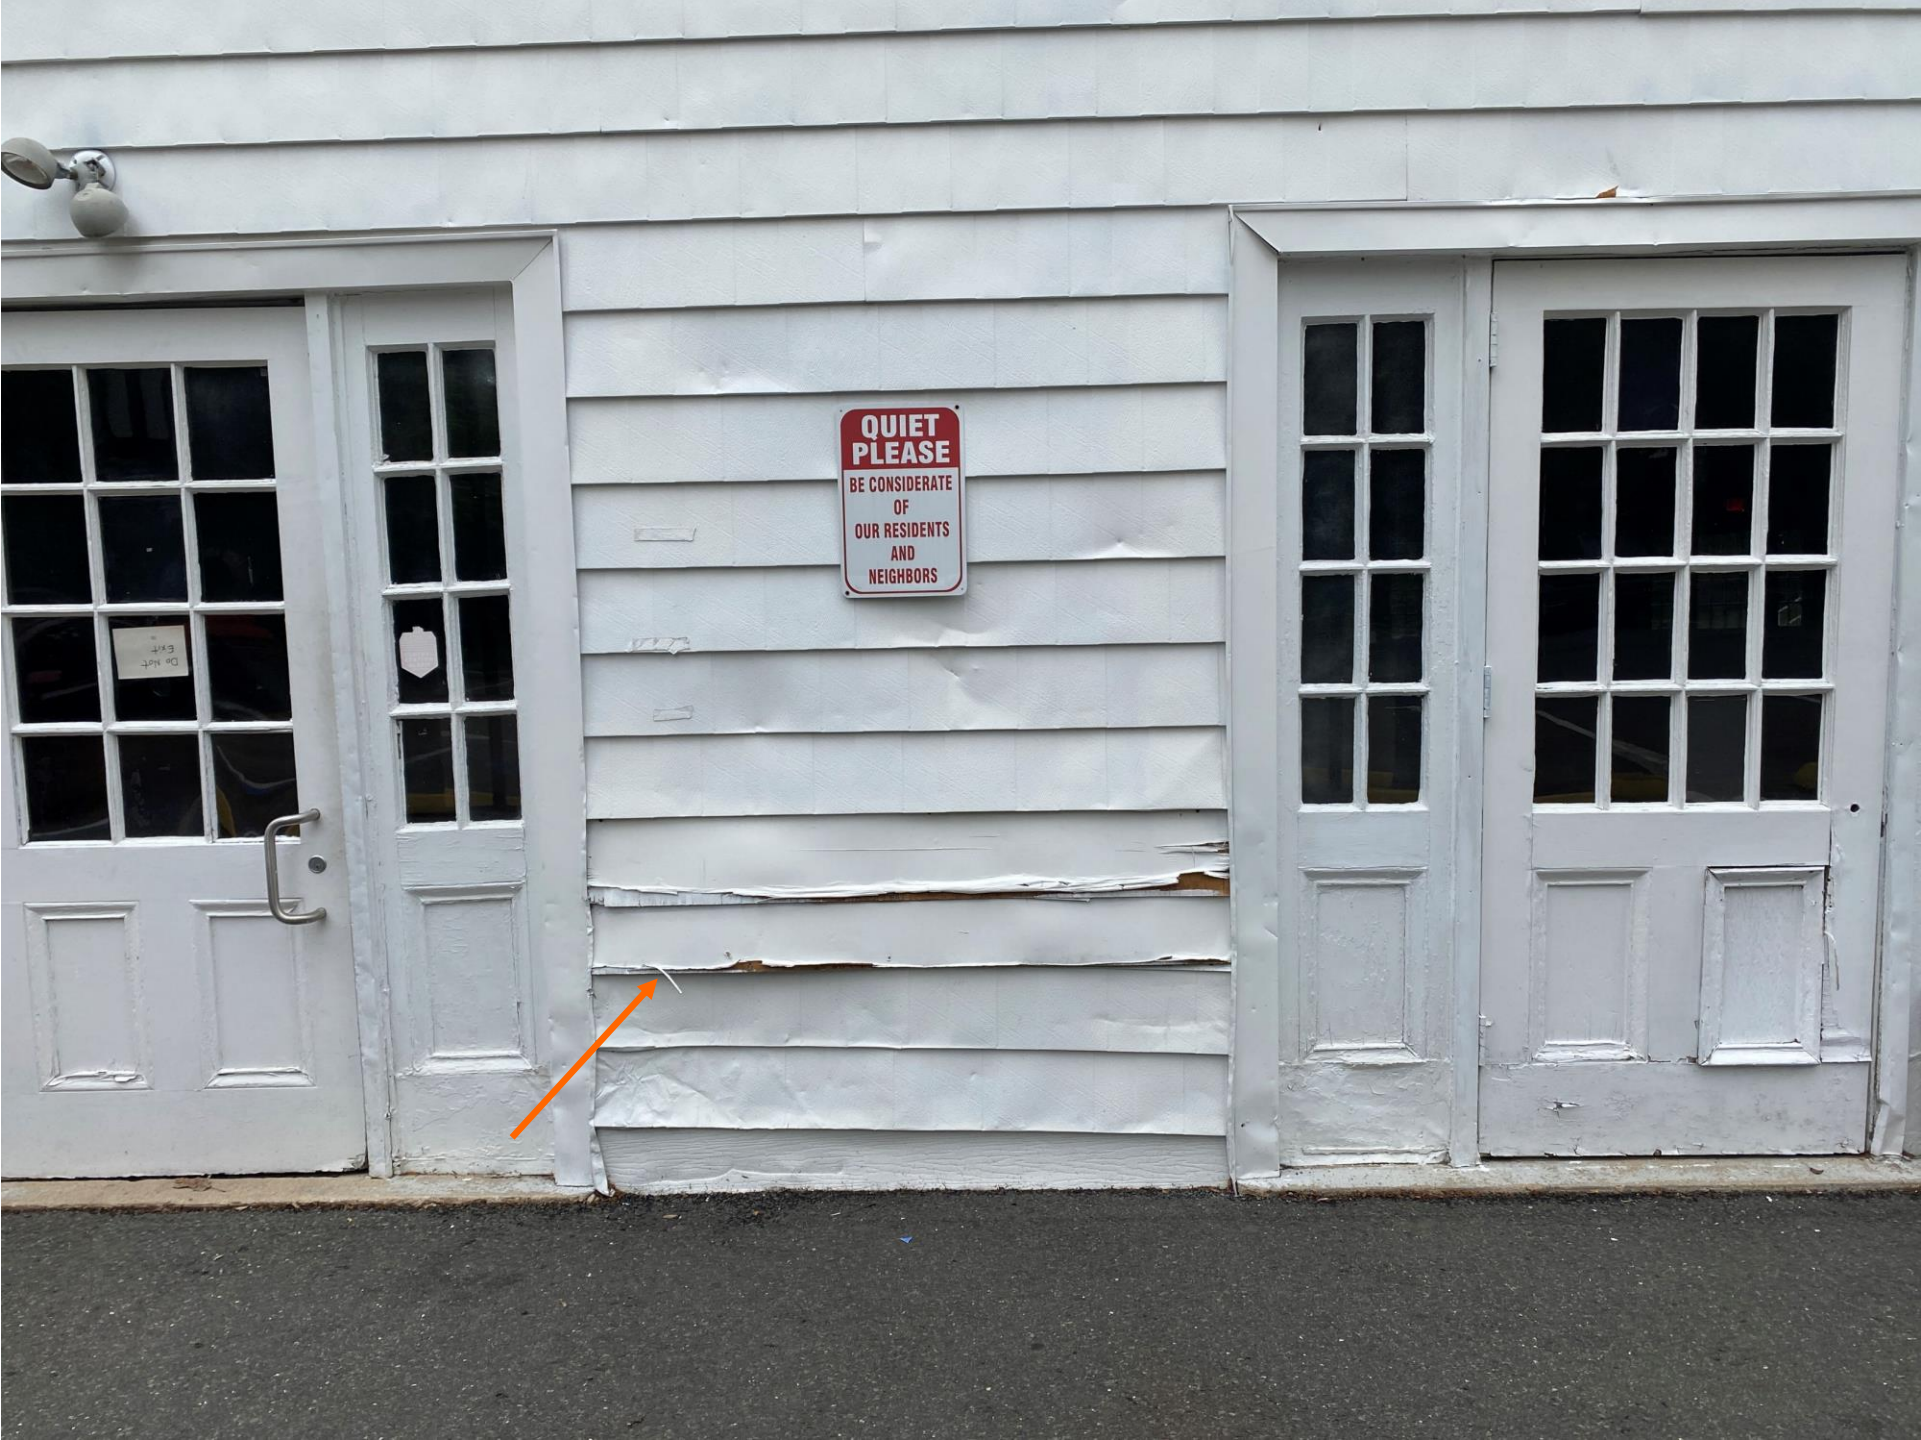
View of replacement siding at the auditorium that looks more like balsa wood.

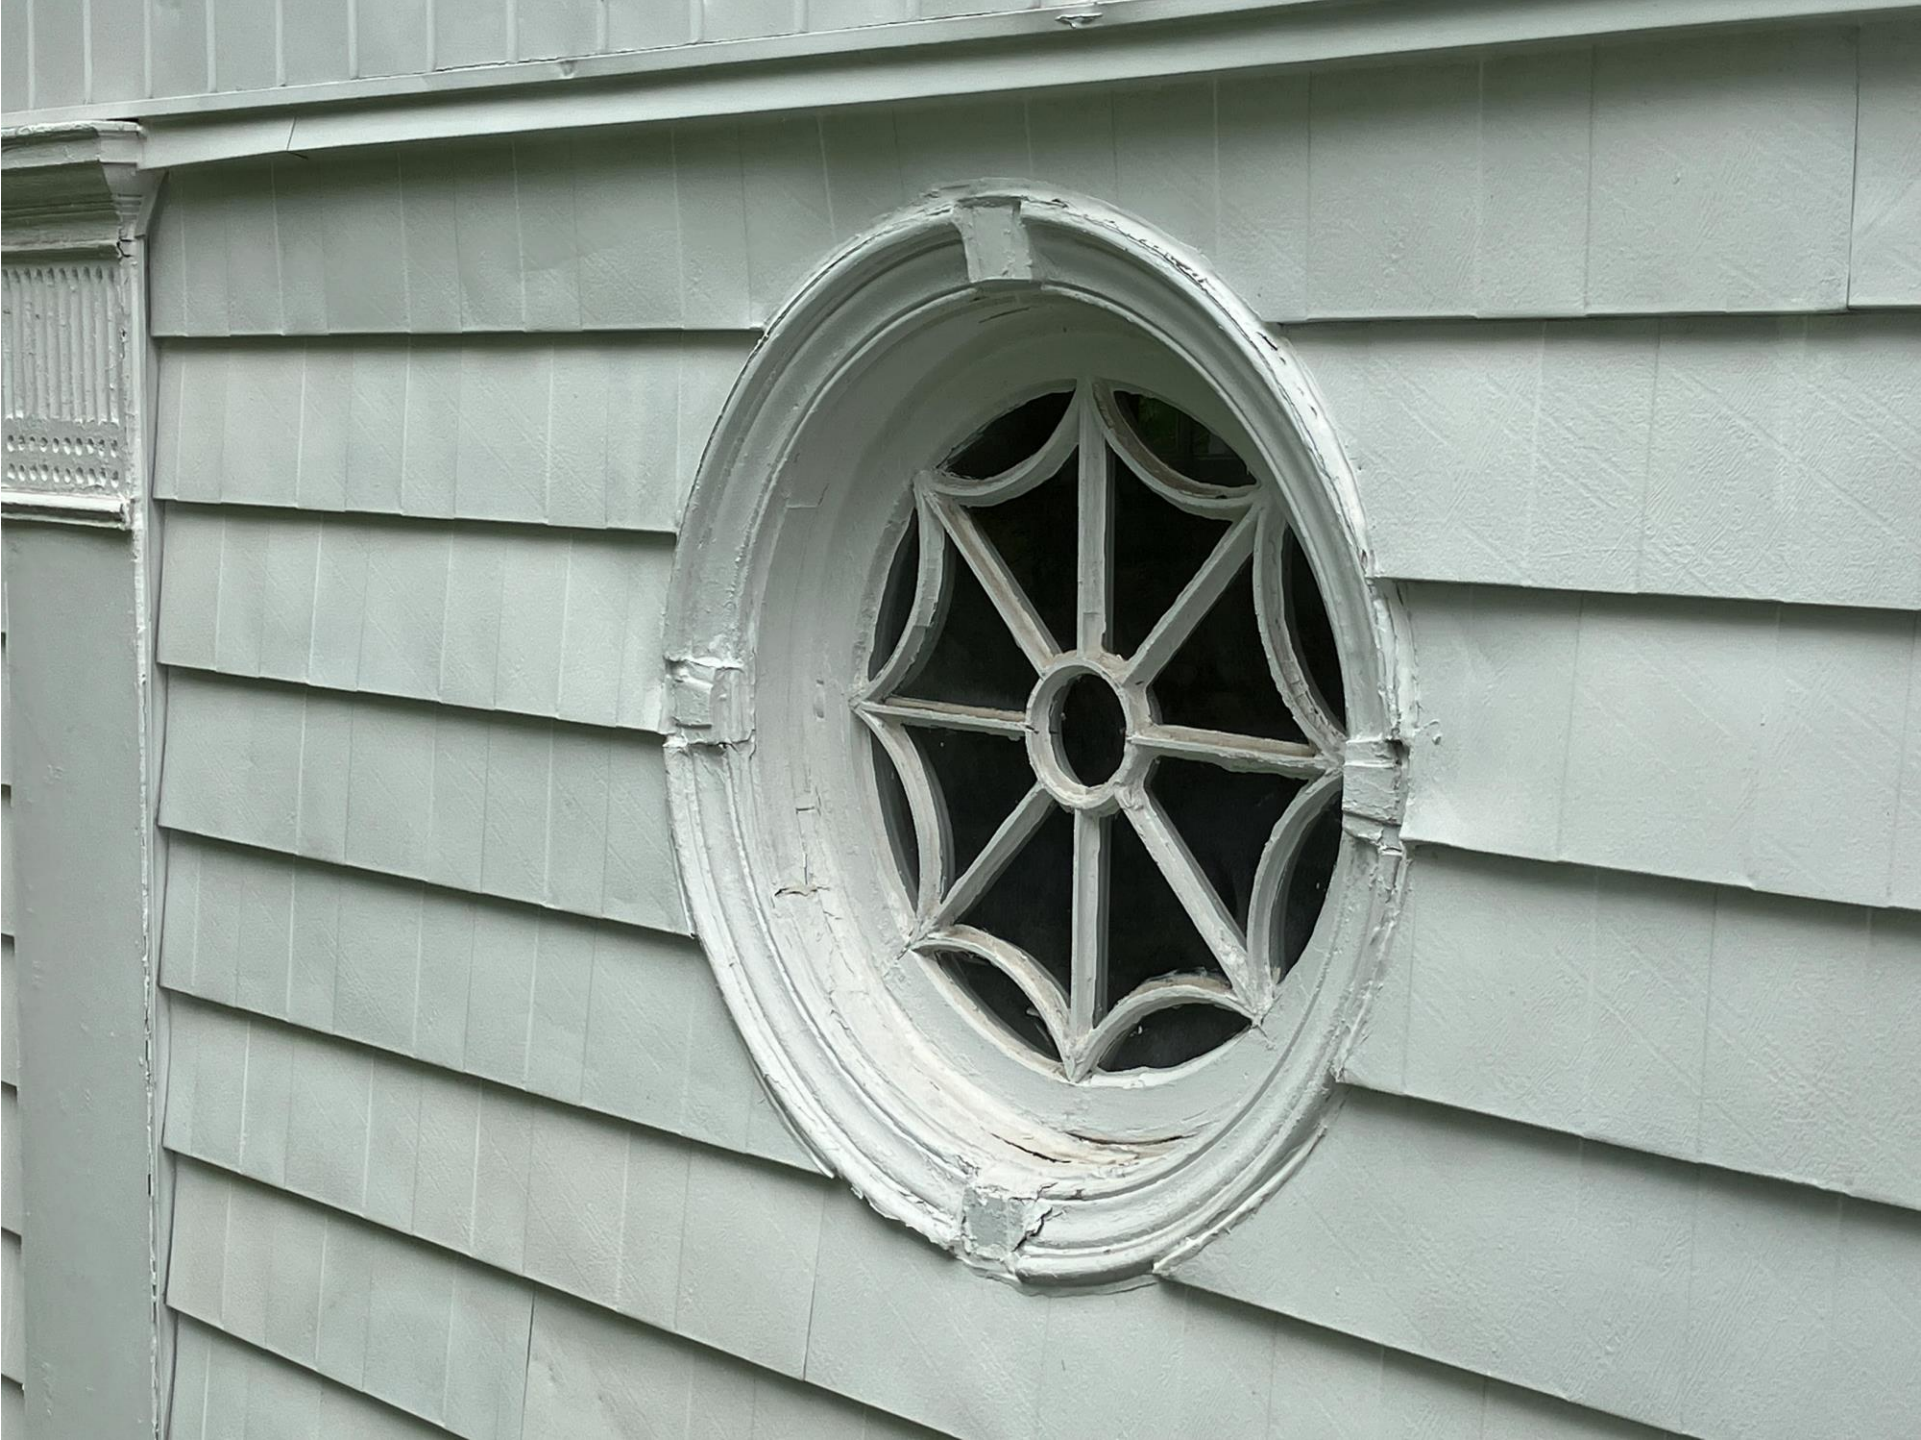
View of the rose window (W317); note the loss of definition in the detailing of the wood surround.

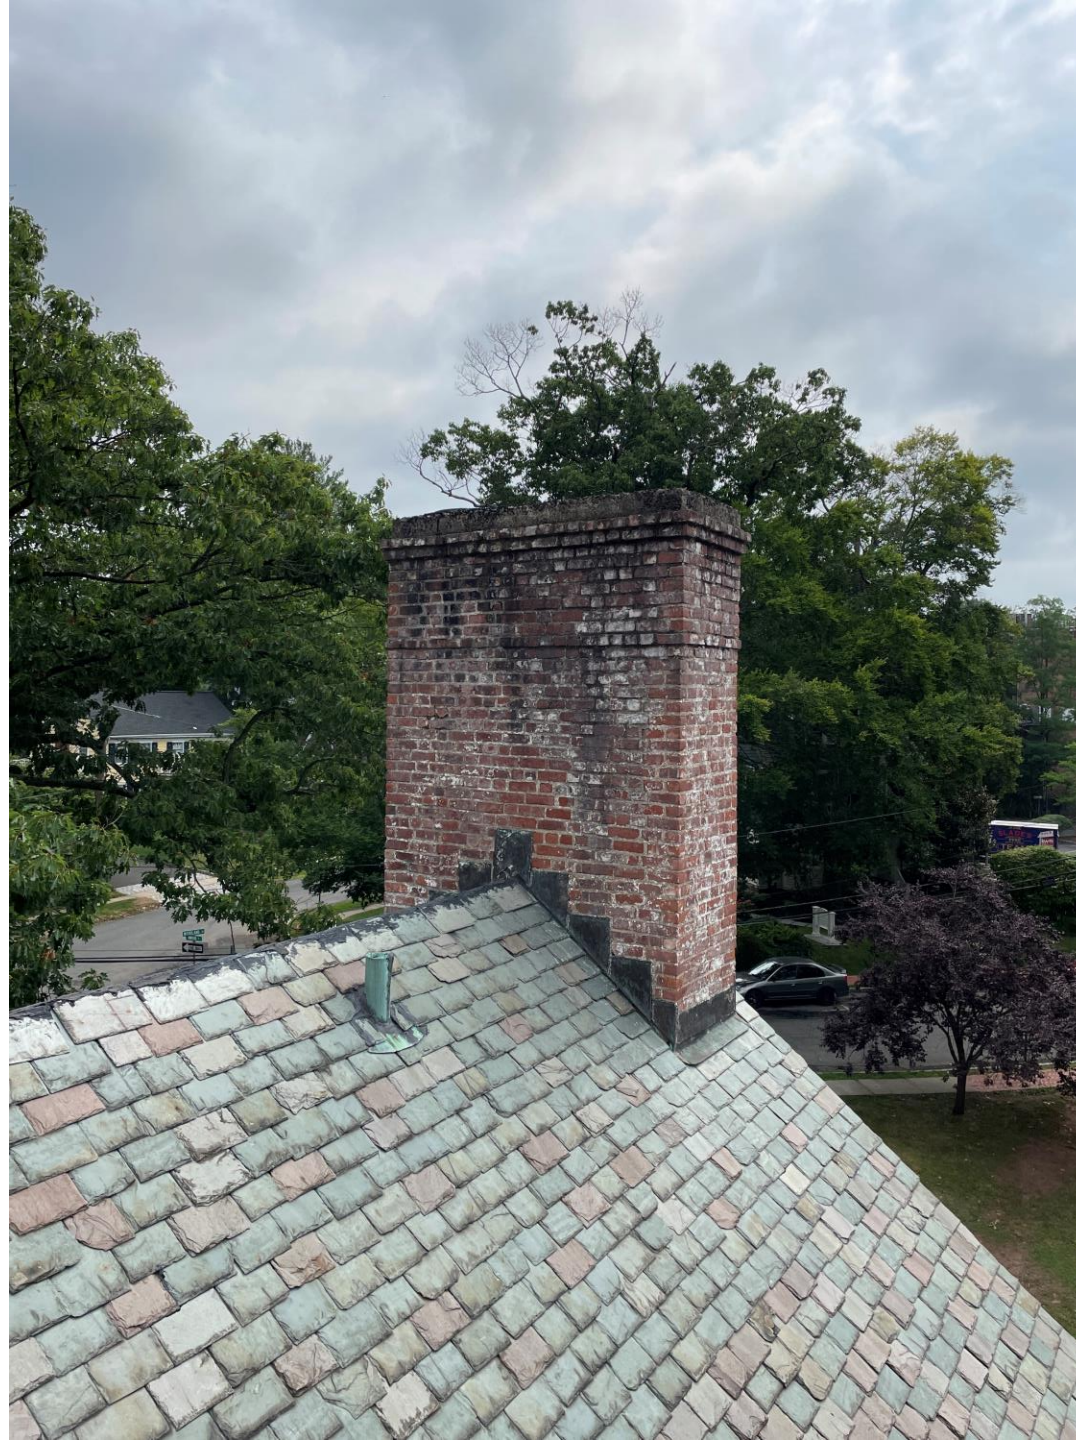
View of roof taken on level with the existing roof showing tar on the slate and you can also see the slate is flaking, cracking, chips, and loss.

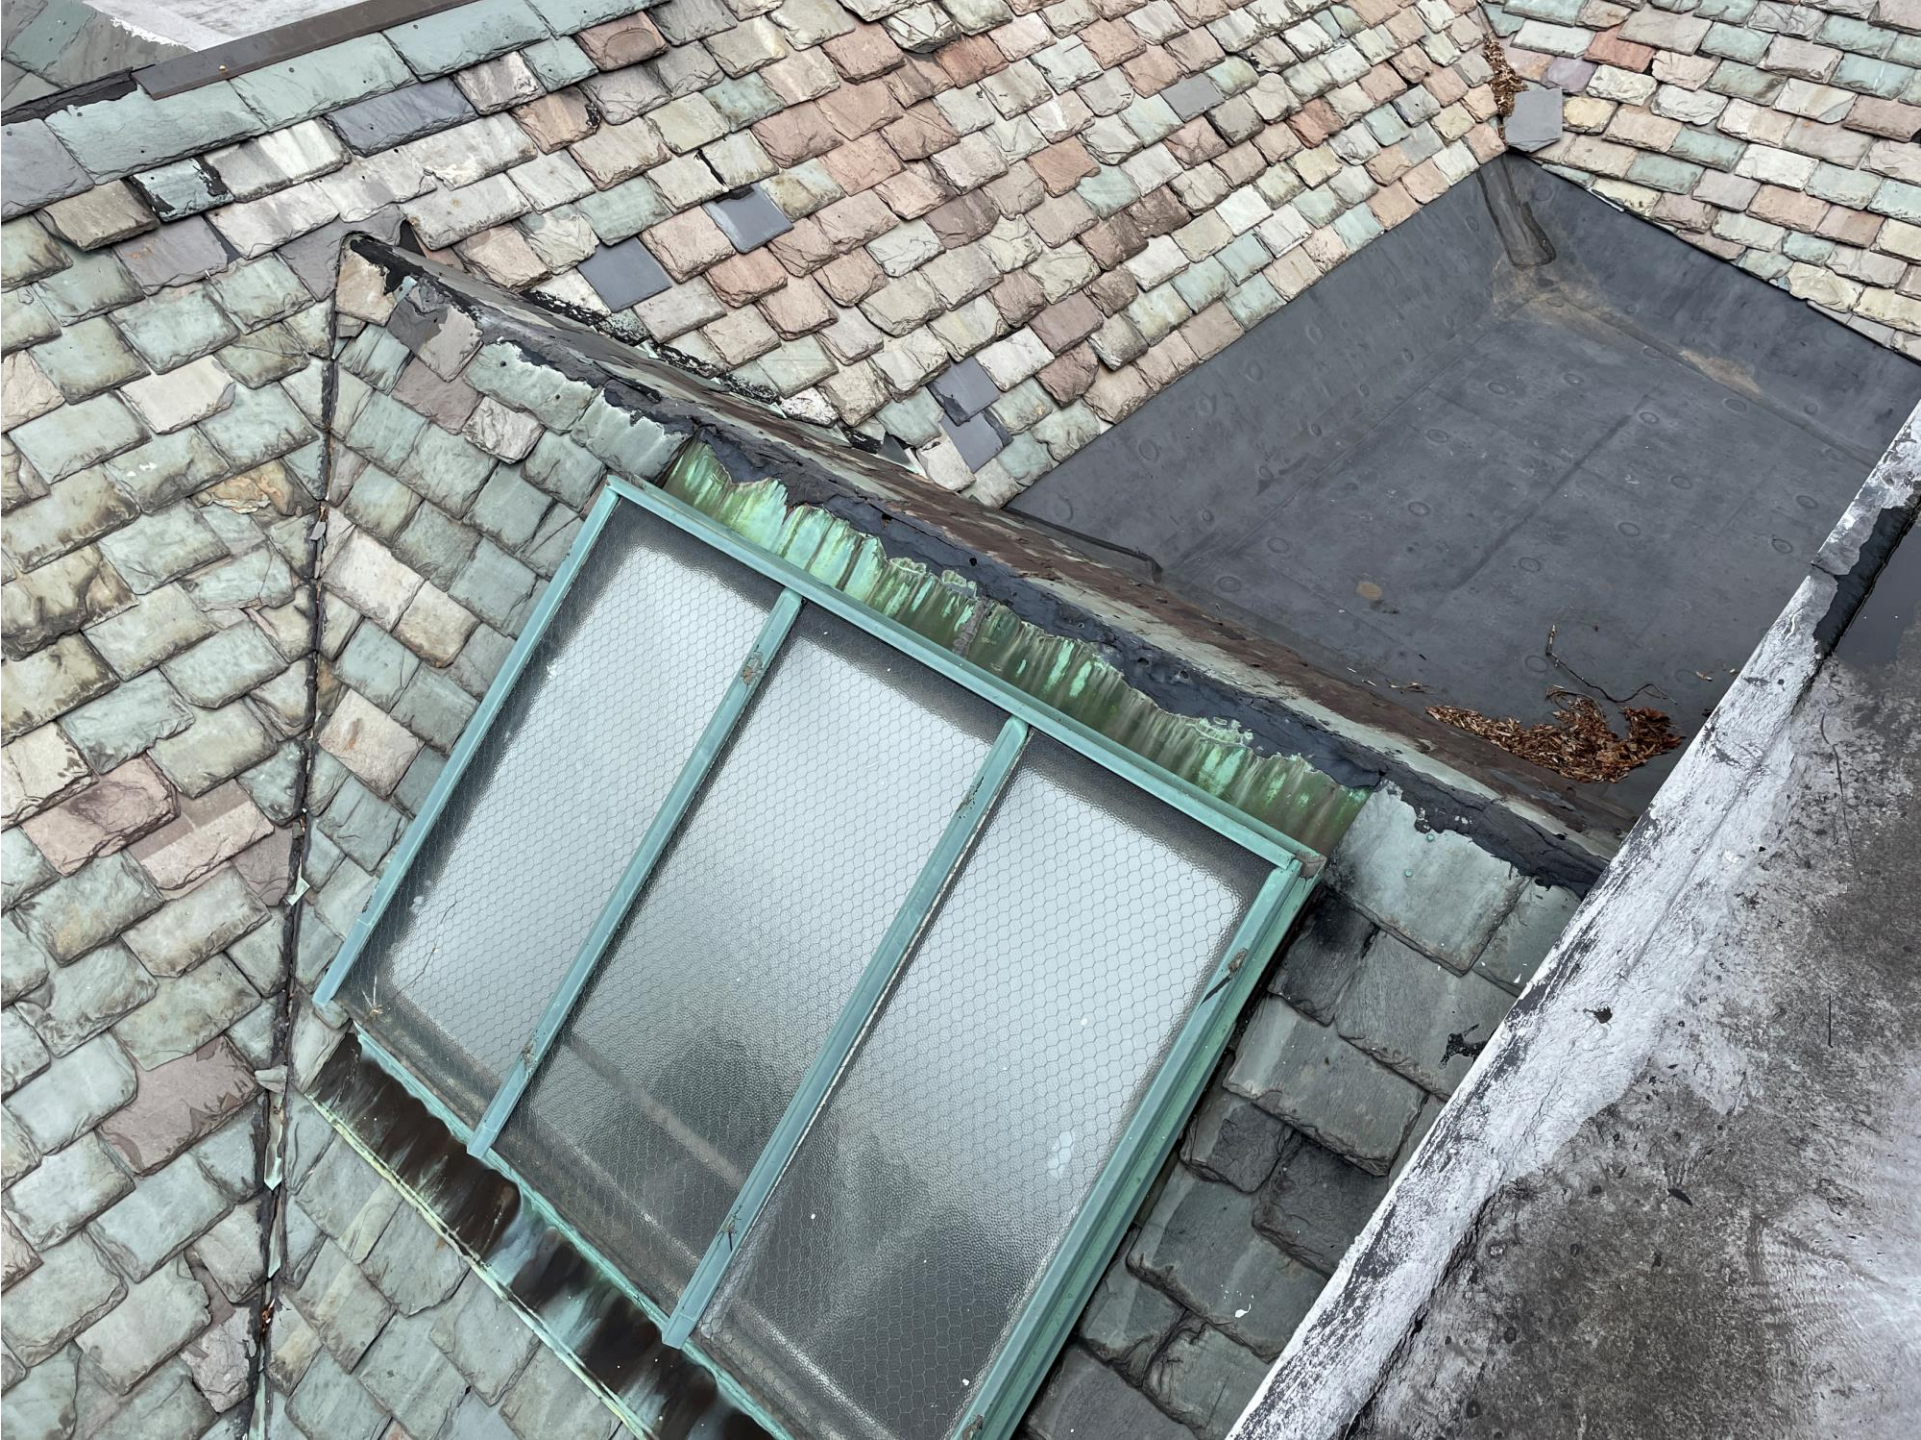
View of a typical skylight (this one is over the kitchen). Note the heavy patinae, and the broken glass at the skylight. Also note the tar on the slate and copper flashings.
