# The Woodland

Findings of the Historic Preservation Plan

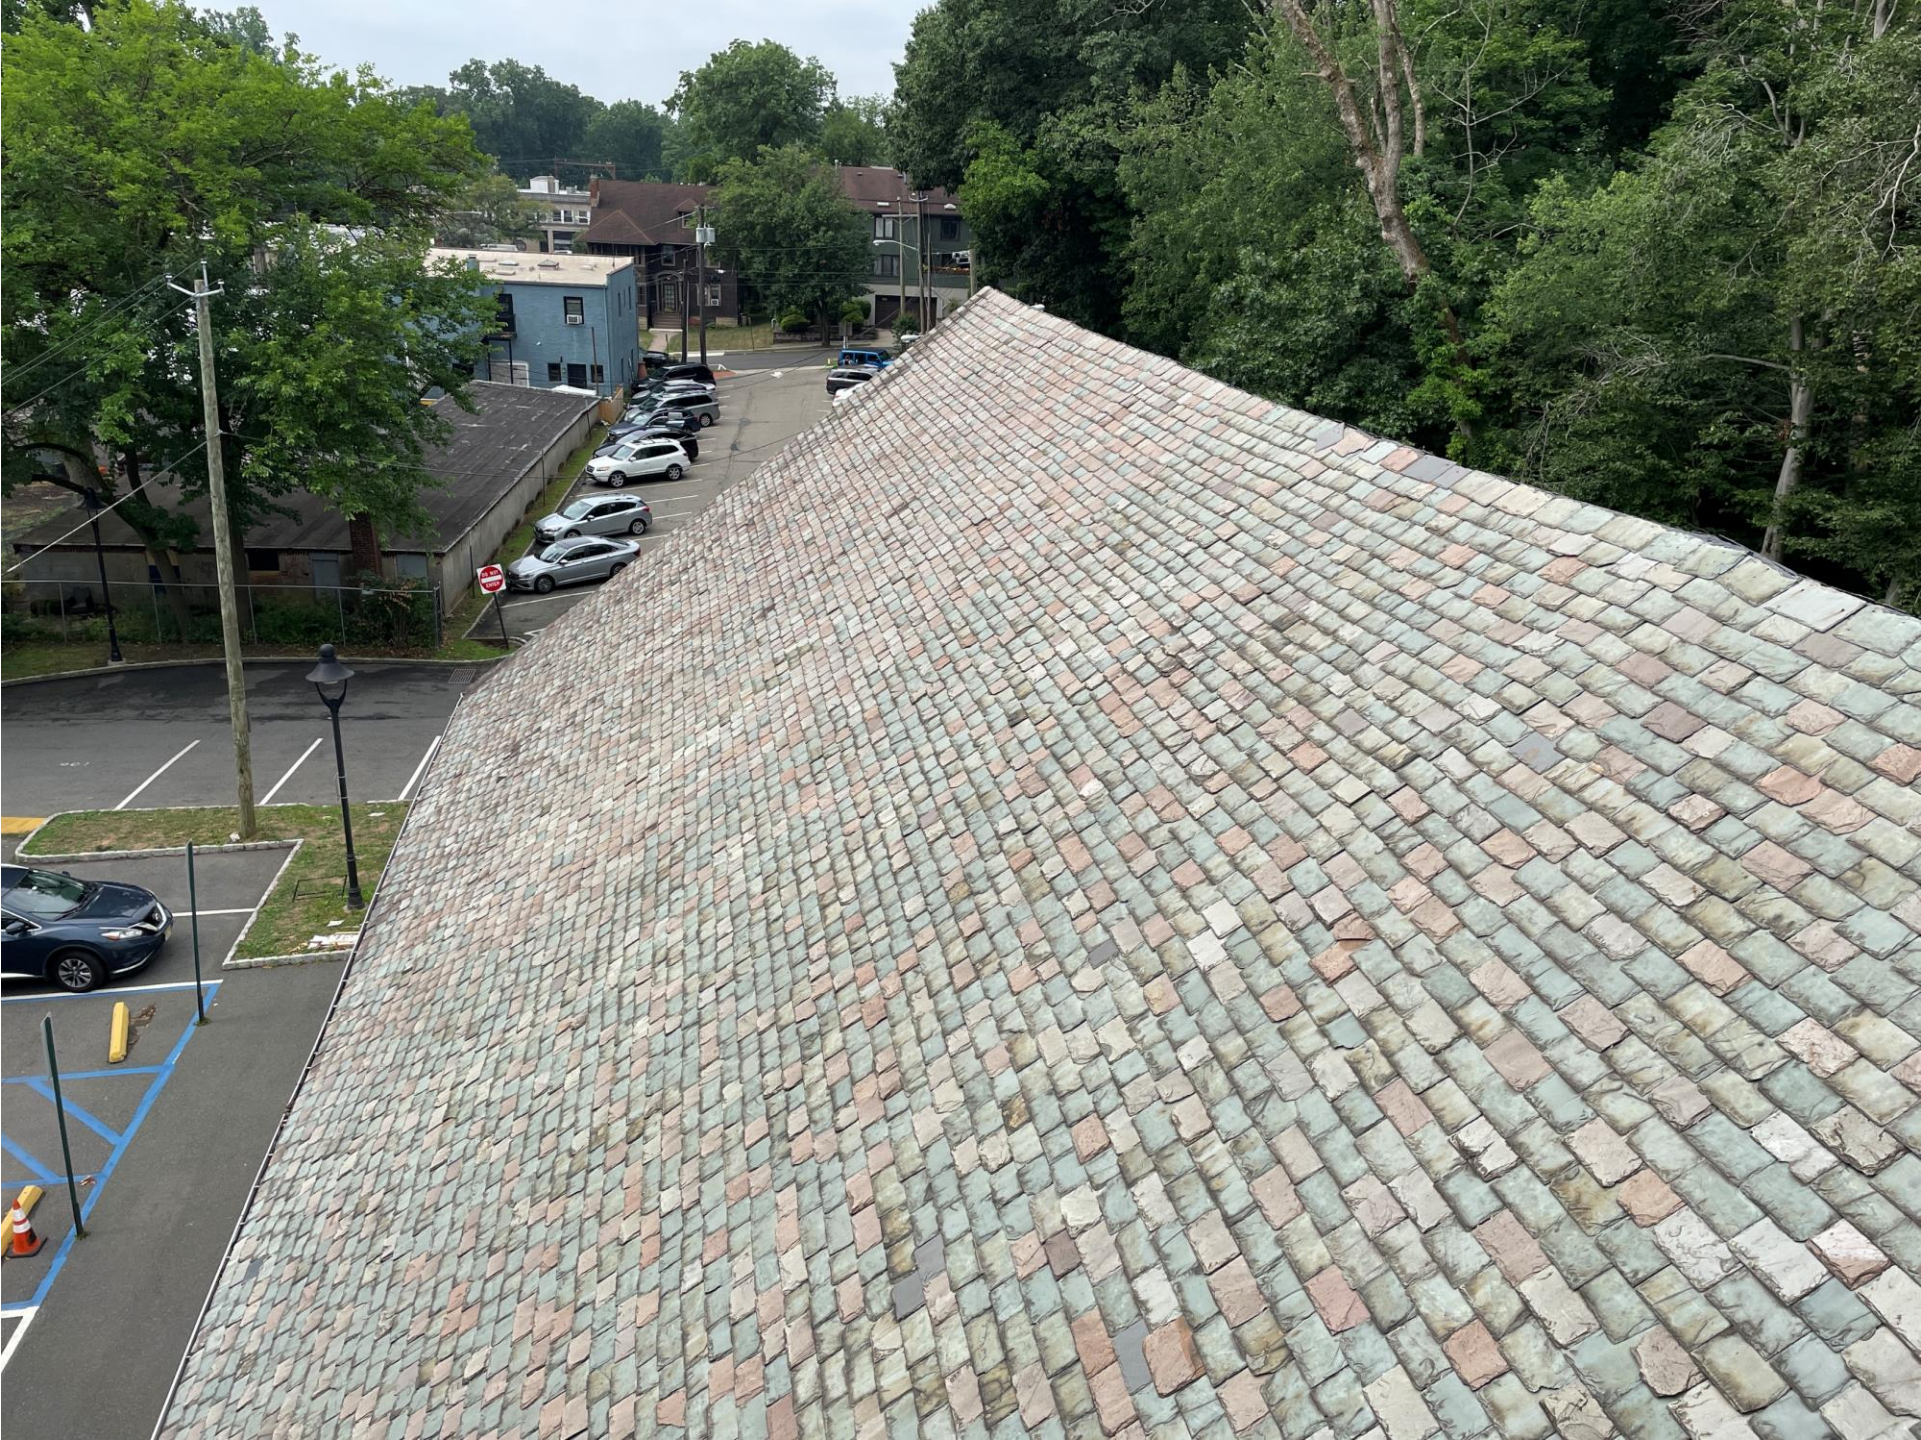
View of auditorium roof showing the condition of the slate but upon close examination the sagging in the roof between the trusses is also visible.
