# The Woodland

Findings of the Historic Preservation Plan

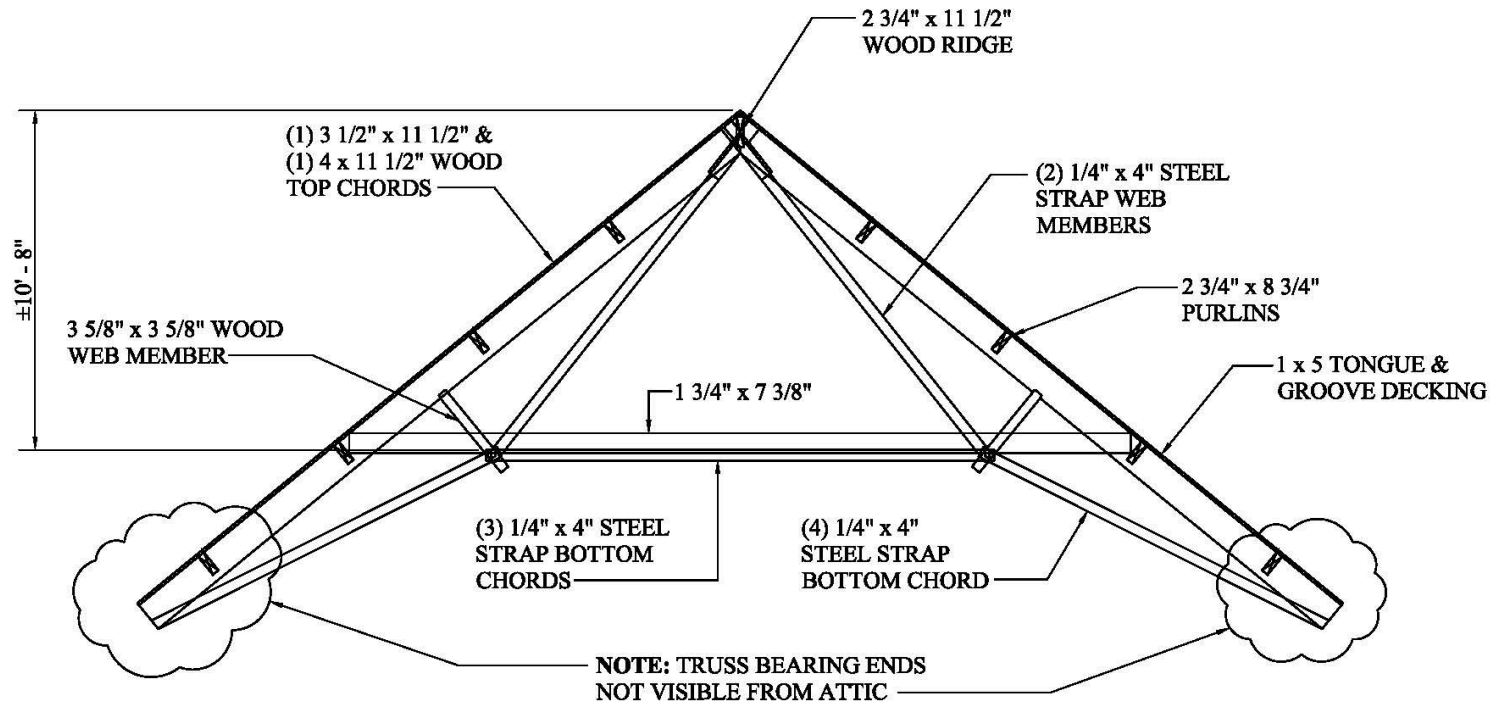
View of auditorium roof showing the condition of the slate but upon close examination the sagging in the roof between the trusses is also visible.

View of auditorium roof scissor truss

- Repair and upgrade of any structural deficiencies at auditorium roof and related work.
- A comprehensive re-roofing that can be broken into building components as this endeavor is projected to be costly.
- Repair and restoration of the roof drainage systems, chimneys, skylights, and other deteriorated roof features.
- Removal of exterior aluminum siding and trim and restoration of the underlying wood shingles and trim and other exterior features; this work can also be undertaken in phases.
- Repair and restoration of the exterior windows and doors with a priority placed on the doors at the auditorium followed by those within window wells.
- Repair and restoration of the features of the side portico.

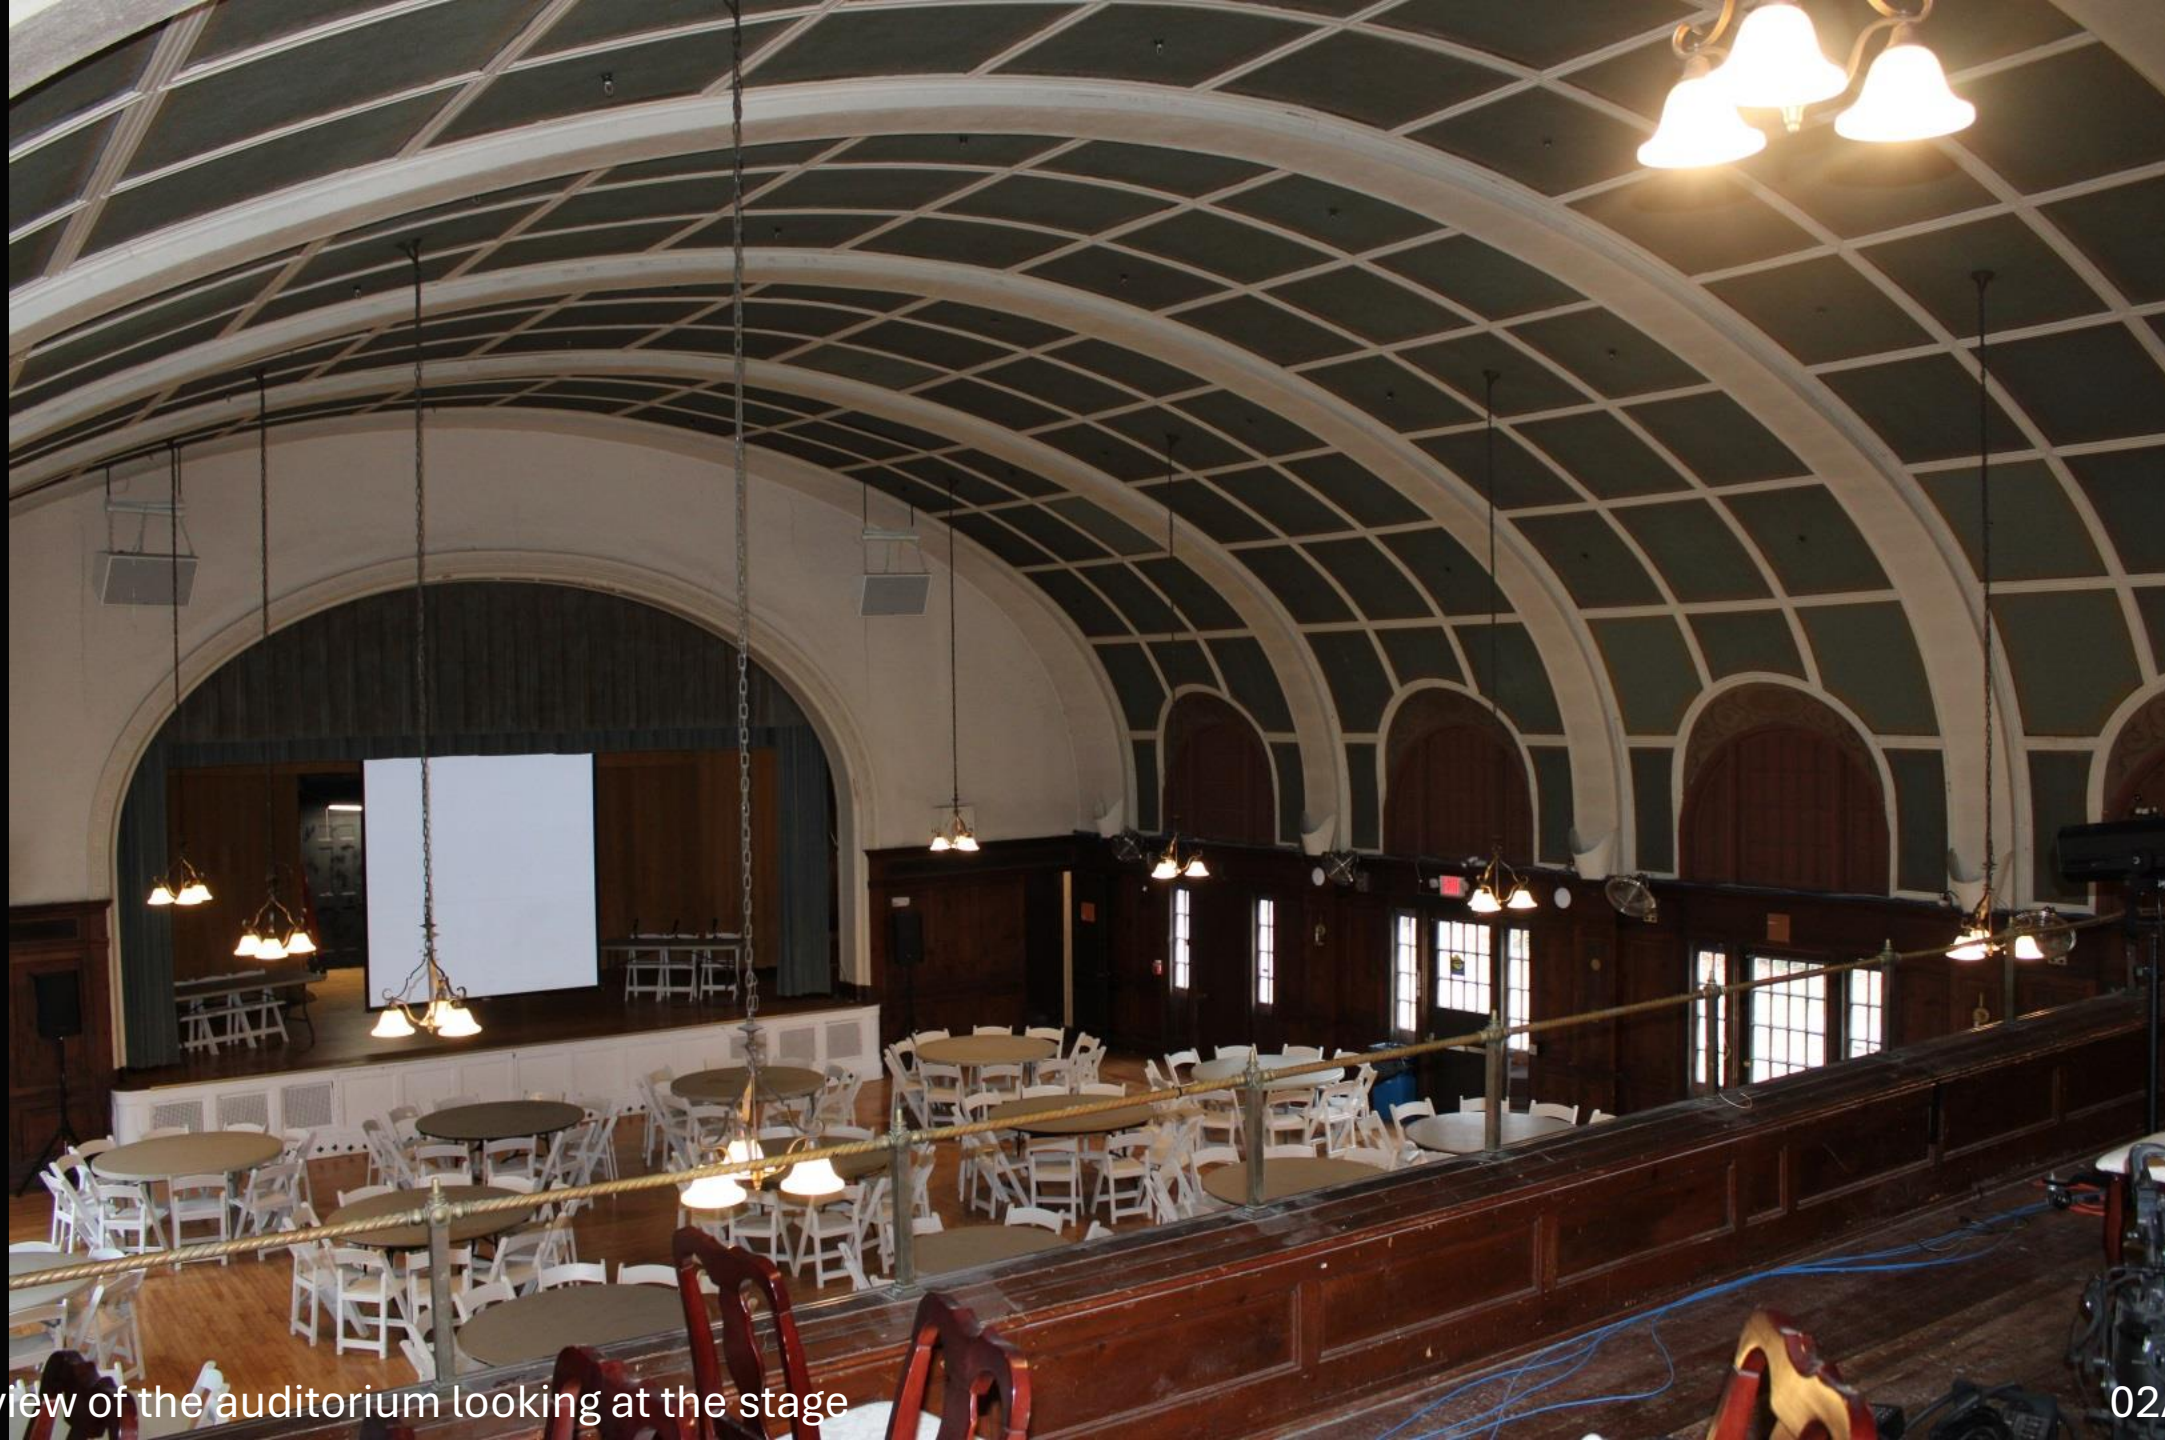
02/02/2024

Overall view of the auditorium looking at the stage

- Upgrade Finishes including at stage
- Improve lighting, add sound equipment, etc.
- Install new HVAC system in auditorium
- Upgrade electrical for new HVAC
- Improve sound transmission to upstairs spaces
- Repair / upgrade exterior portico
- Repair windows and doors at stage
- Improve conditions at basement windows and window wells

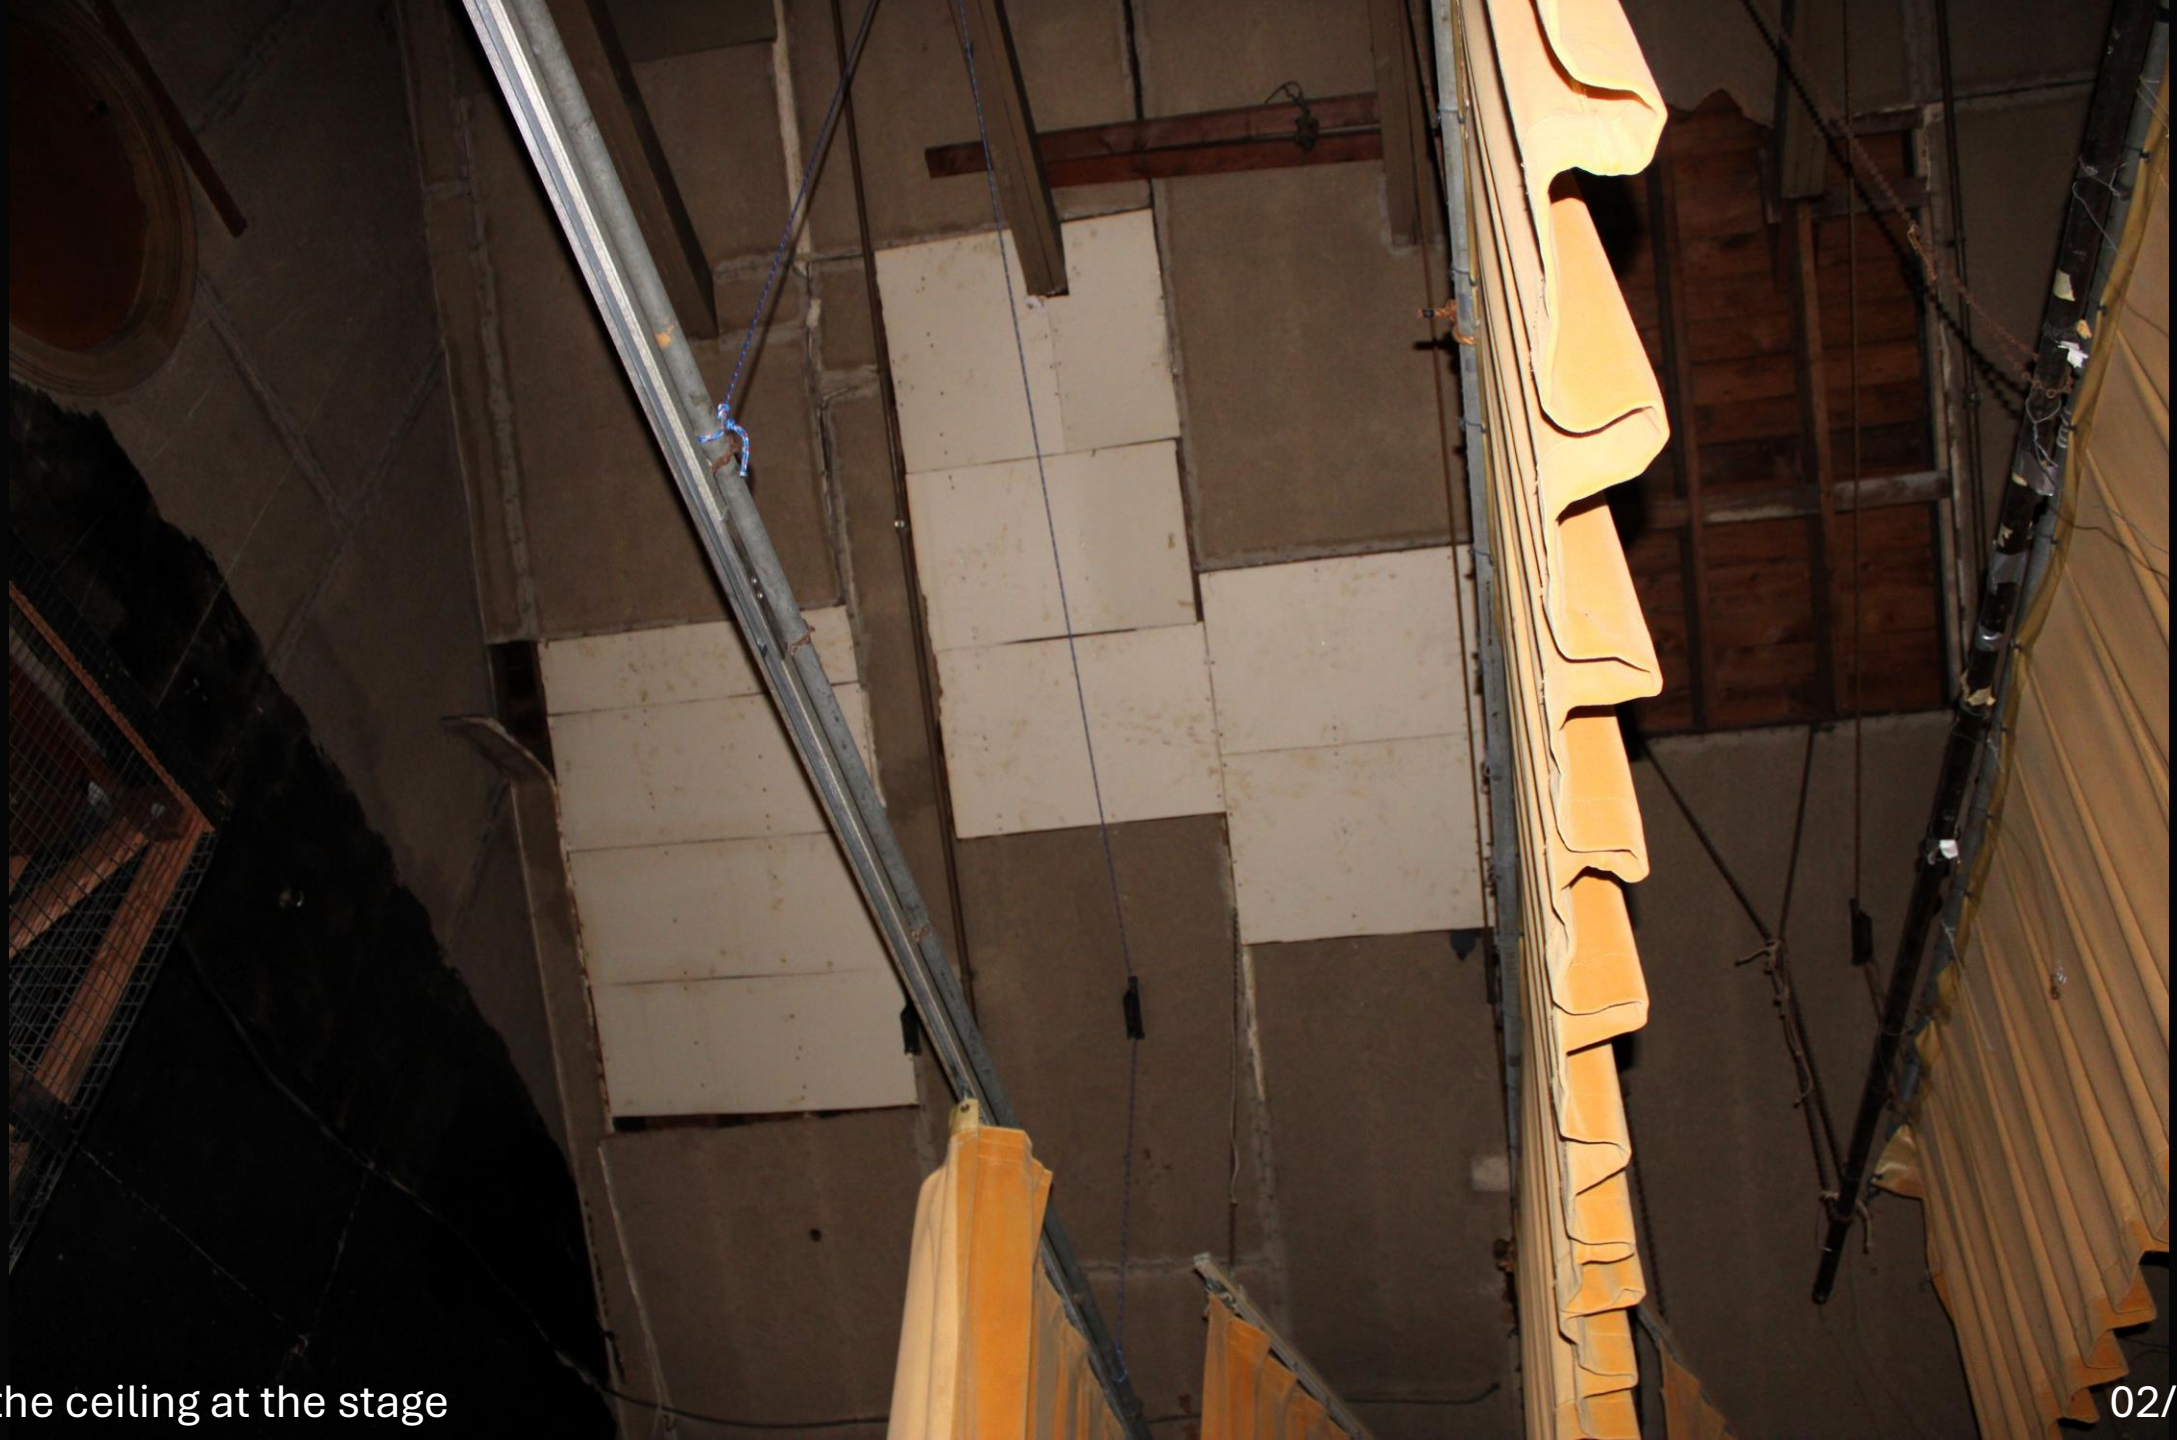
02/02/2024

View of the ceiling at the stage
